**SITE ASSESSMENT REPORT
FOR
Emchem Corporation Site
Houston, Harris County, Texas**

DATE: February 28, 1993

SUBJ: Site Assessment Report: Emchem Corporation Site
Pearland, Brazoria County, Texas
TDD# T06-9210-079
PAN# ETX0139SAA

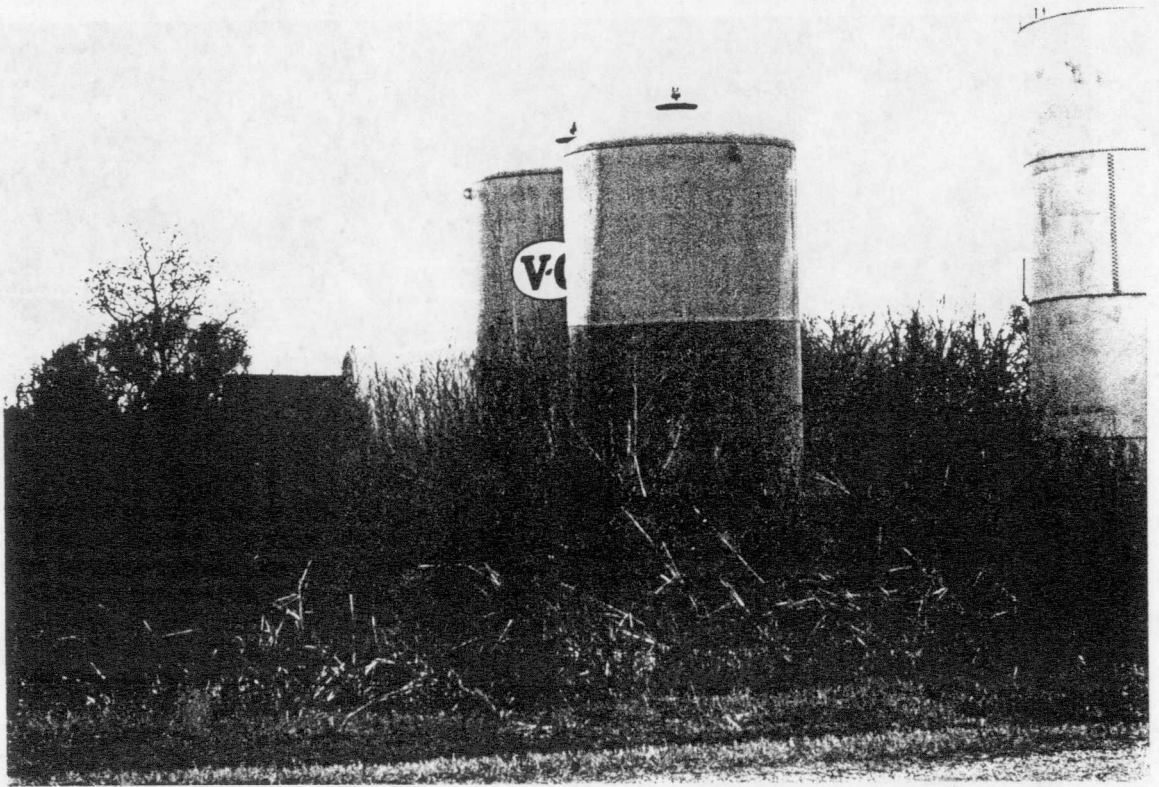
SITE NAME: EMCHEM CORPORATION TDD#: T06-9210-079
 PHOTO#: 201 PHOTOGRAPHER\WITNESS: REDDY/HAGLUND
 DATE: 01/12/93 TIME: 1012 DIRECTION: SW
 NORTHERN EDGE OF EMCHEM CORPORATION WITH TANKS.

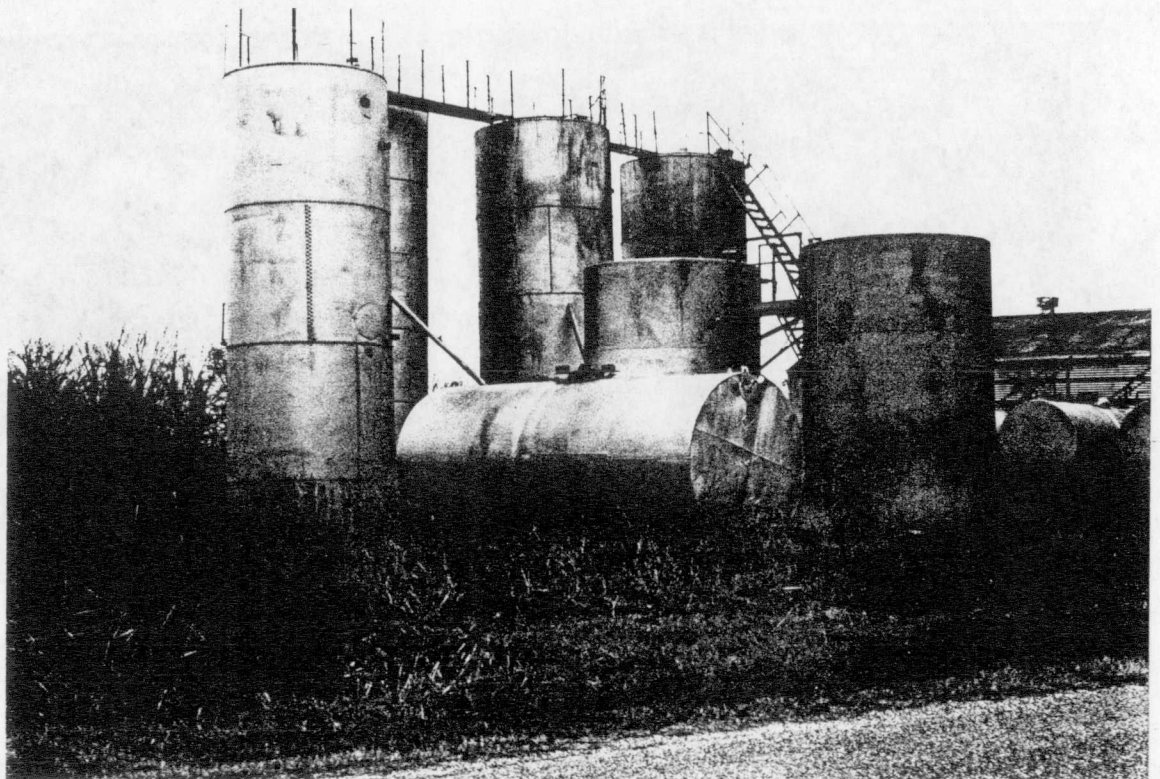
SITE NAME: EMCHEM CORPORATION TDD#: T06-9210-079
 PHOTO#: 202 PHOTOGRAPHER\WITNESS: REDDY/HAGLUND
 DATE: 01/12/93 TIME: 1012 DIRECTION: SW
 NORTHERN EDGE OF EMCHEM CORPORATION WITH TANKS.

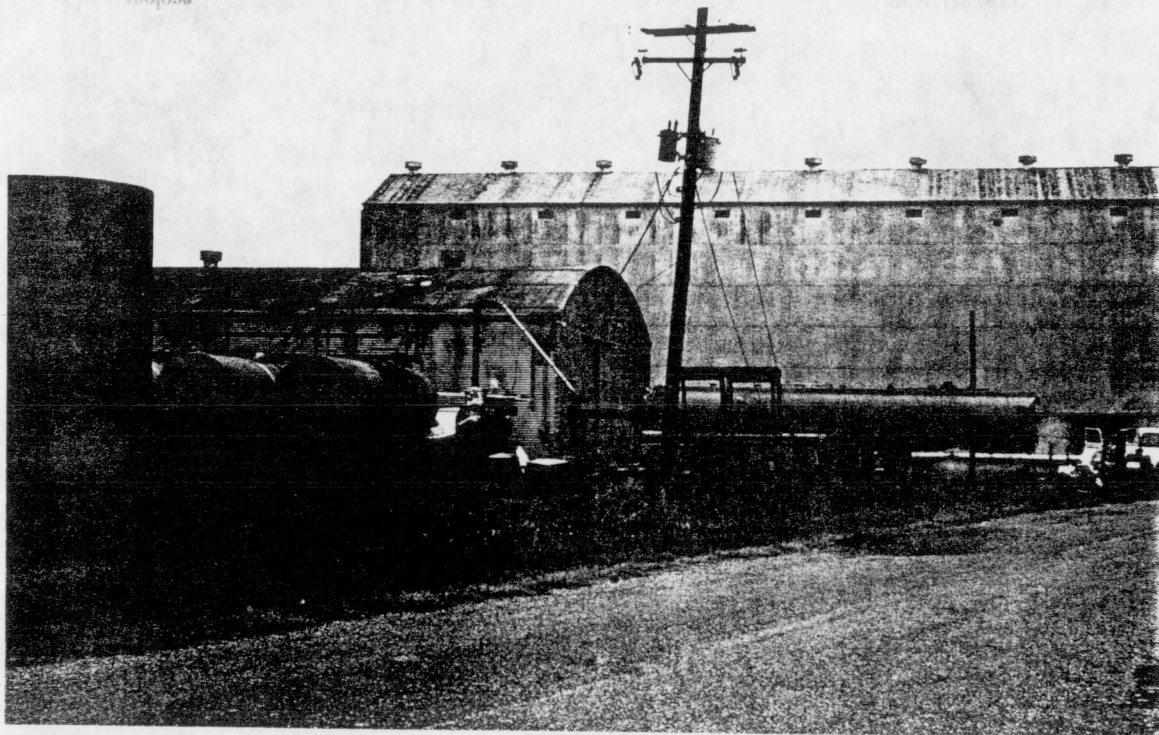
SITE NAME: EMCHEM CORPORATION TDD#: T06-9210-079
 PHOTO#: 203 PHOTOGRAPHER\WITNESS: REDDY/HAGLUND
 DATE: 01/12/93 TIME: 1012 DIRECTION: W
 NORTHERN EDGE OF EMCHEM CORPORATION WITH TANKS.

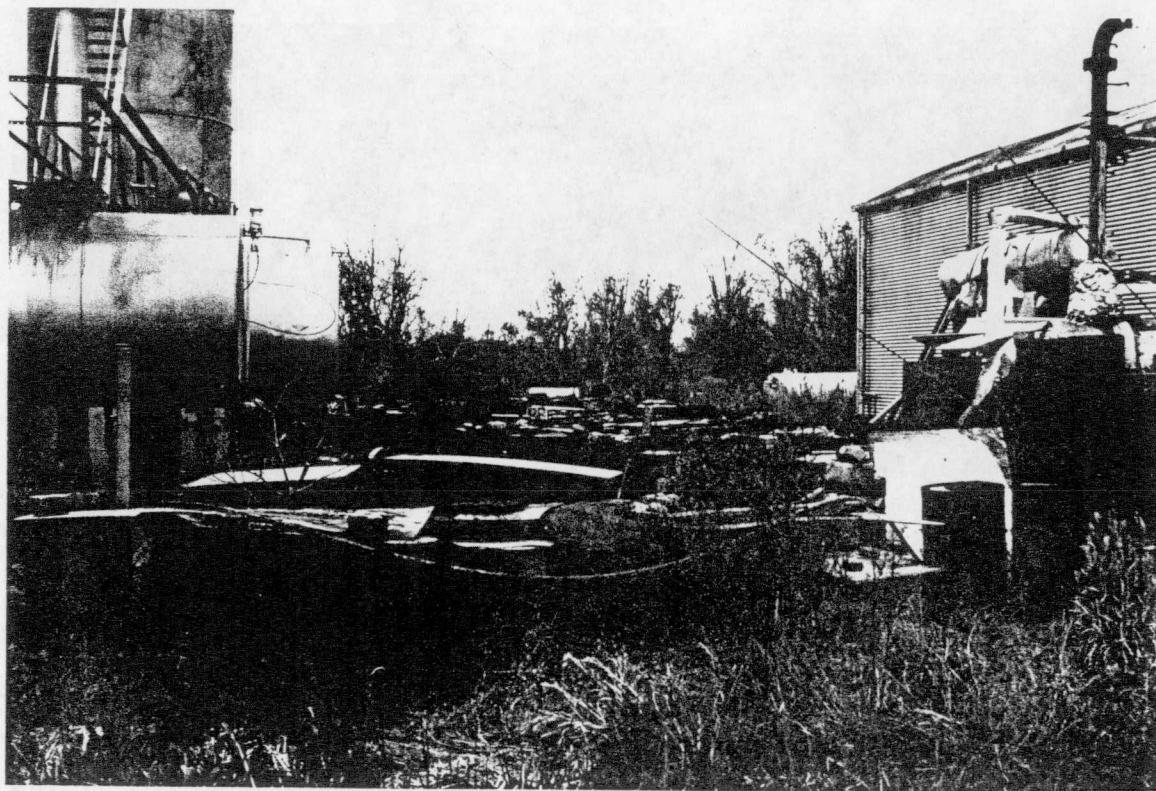
According to Miller, the drums stored outside contain unwanted by-products and waste materials from chemical reactions. All of the 150-200 drums were rusted and completely exposed to outside conditions. TAT observed extensively stained soil in the drum area and a sheen on nearby standing water (Attachment B). Ten of the facility's tanks, which appeared to be in good condition, contain a mixture of tri- and tetraethylene glycol. According to Miller, samples taken from tanks T18 and EBT would be fairly representative of the mixtures in the majority of the tanks. Tank contents and approximate volumes are detailed in Attachment G.

SITE NAME: EMCHEM CORPORATION TDD#: T06-9210-079
 PHOTO#: 204 PHOTOGRAPHER\WITNESS: REDDY/HAGLUND
 DATE: 01/12/93 TIME: 1013 DIRECTION: S
 DRUMS NEAR WAREHOUSE ON EMCHEM SITE.

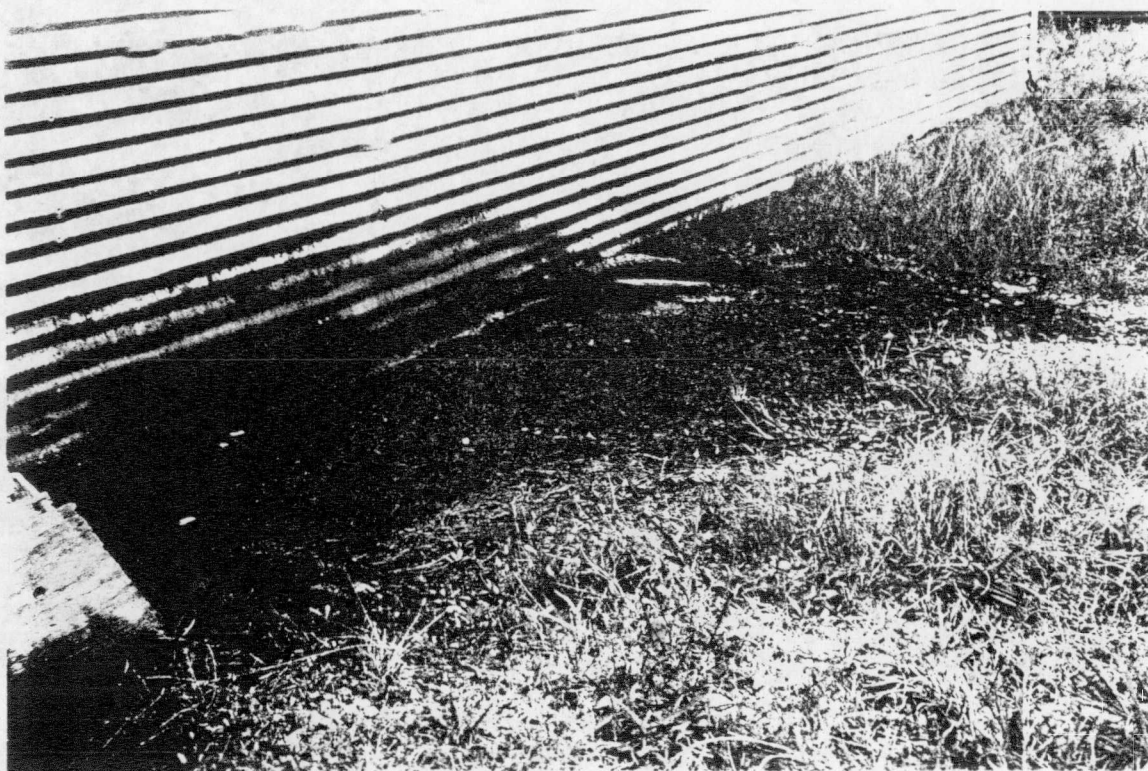
SITE NAME: EMCHEM CORPORATION TDD#: T06-9210-079
 PHOTO#: 207 PHOTOGRAPHER/WITNESS: REDDY HAGLUND
 DATE: 01/12/93 TIME: 1016 DIRECTION: SE
 STAINED SOIL ON WEST SIDE OF WAREHOUSE.

Stained soil is visible to the west of the warehouse and documented.

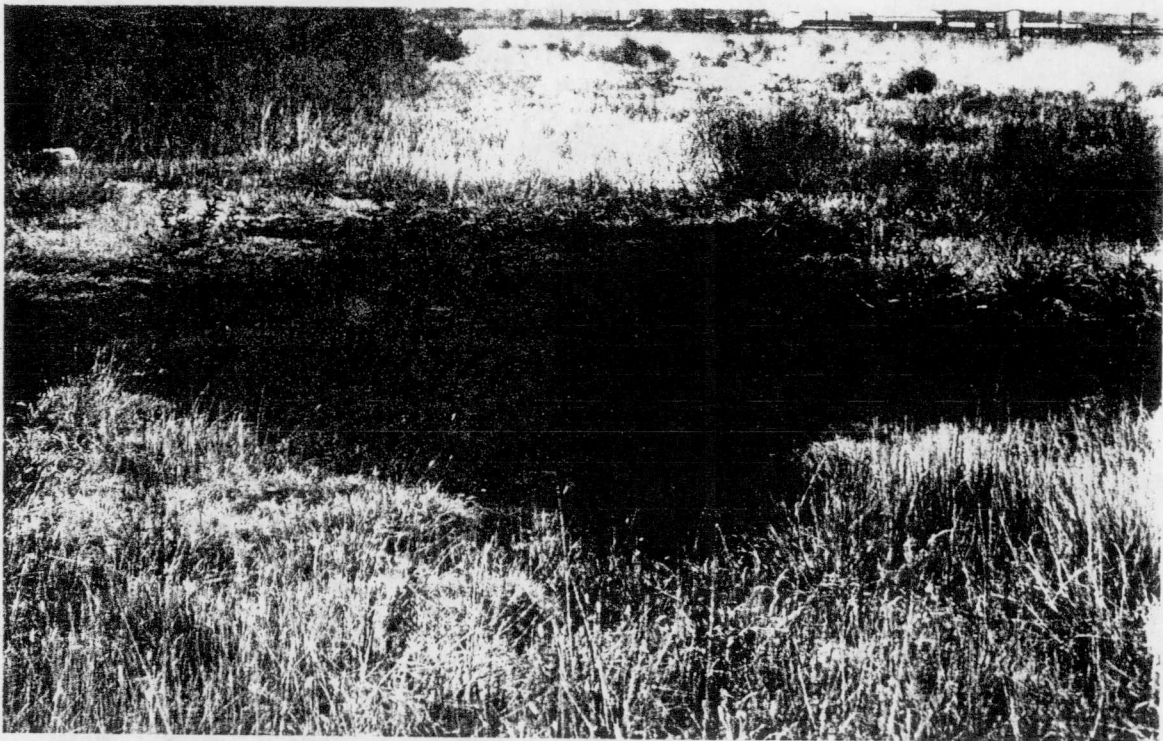
Miller stated that the patch of black, asphalt-like material to the southwest of the warehouse is a furan-resin poured to fill a low area. Residuals of this material can be found in tank N3 (Attachment B). He also said that the "landfarm" area in the southeast corner of the site contains very dark brown and orange solid materials enclosed by a berm. According to Miller, the landfarm contains inert by-products of various chemical processes. Miller attributed the stained soil visible in several locations to the polyethylene glycol materials.

SITE NAME: EMCHEM CORPORATION TDD#: T06-9210-079
 PHOTO#: 208 PHOTOGRAPHER\WITNESS: REDDY/HAGLUND
 DATE: 01/12/93 TIME: 1016 DIRECTION: S
 FURAN RESIN USED AS FILL MATERIAL SW OF WAREHOUSE.

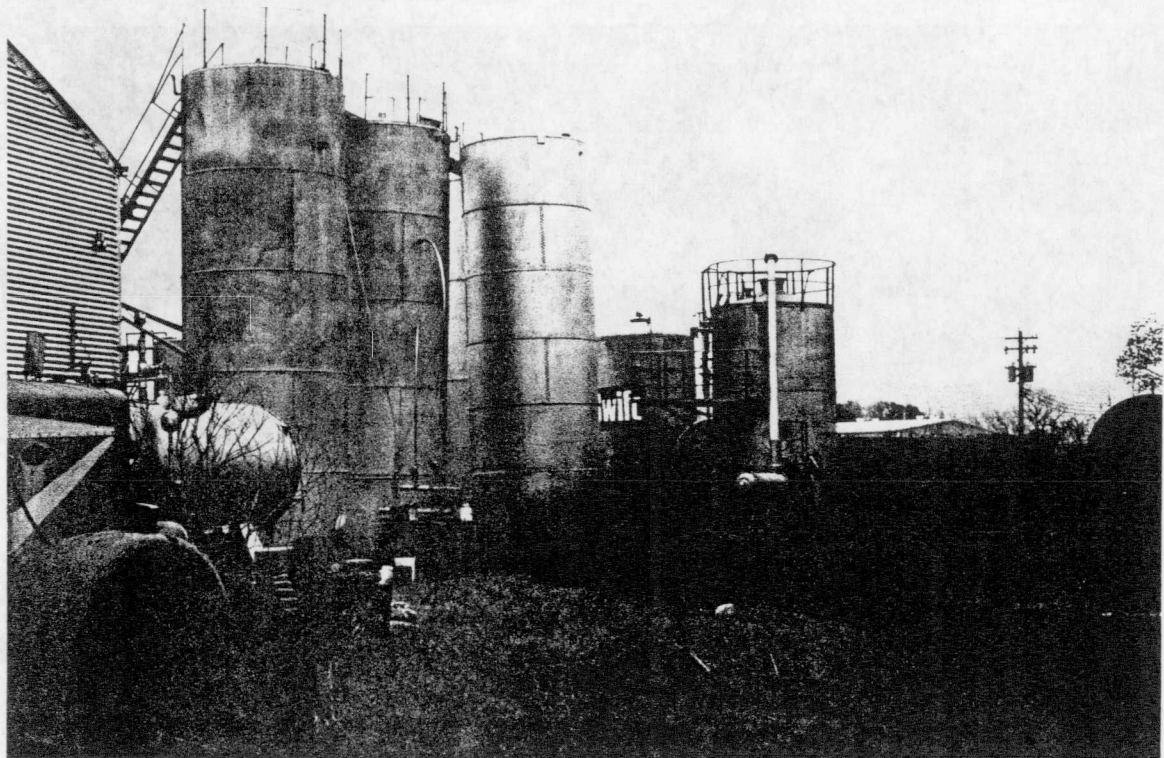
SITE NAME: EMCHEM CORPORATION TDD#: T06-9210-079
 PHOTO#: 210 PHOTOGRAPHER\WITNESS: REDDY/HAGLUND
 DATE: 01/12/93 TIME: 1018 DIRECTION: NE
 DRUMS AND ABOVE GROUND TANKS.

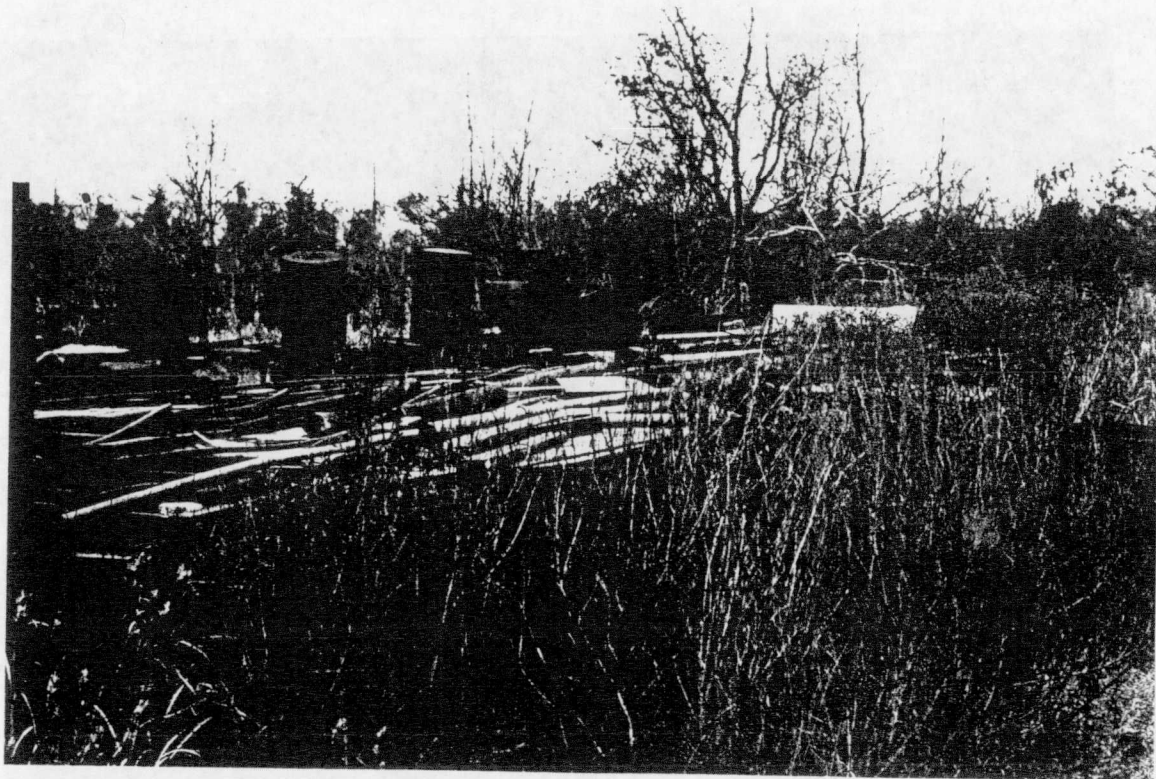
SITE NAME: EMCHEM CORPORATION TDD#: T06-9210-079
 PHOTO#: 213 PHOTOGRAPHER\WITNESS: REDDY/HAGLUND
 DATE: 01/12/93 TIME: 1021 DIRECTION: S
 DRUMS SE OF WAREHOUSE.

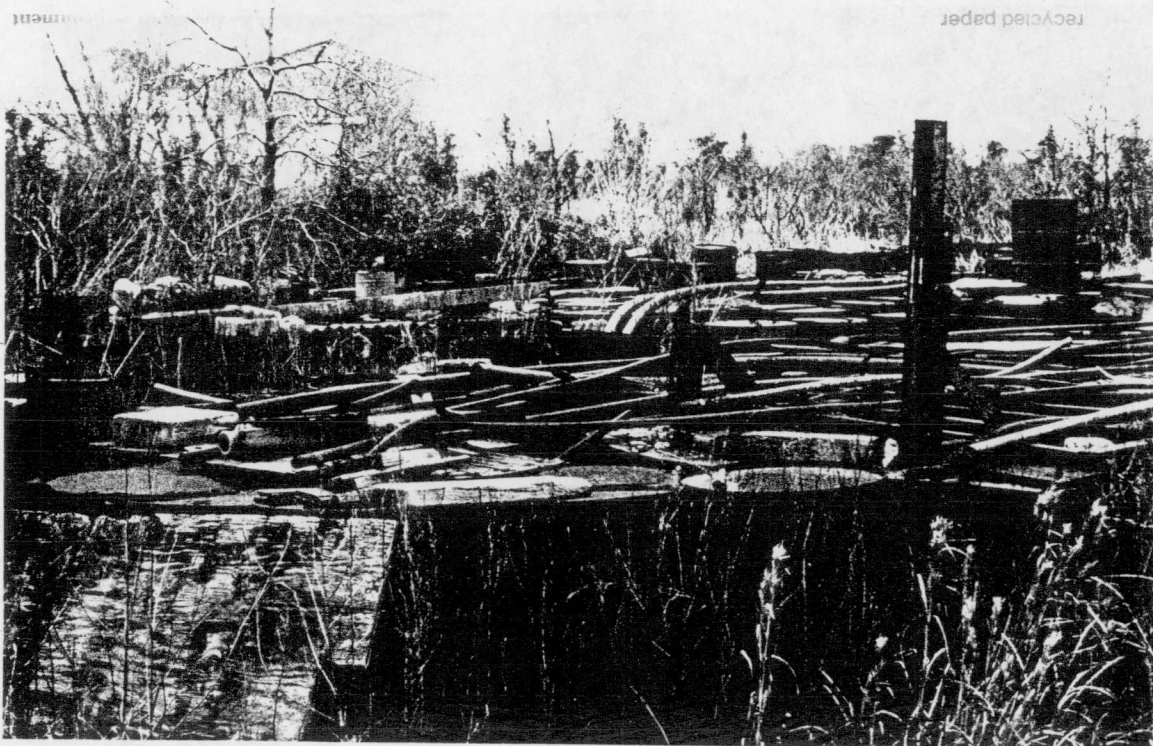
SITE NAME: EMCHEM CORPORATION TDD#: T06-9210-079
 PHOTO#: 214 PHOTOGRAPHER\WITNESS: REDDY/HAGLUND
 DATE: 01/12/93 TIME: 1021 DIRECTION: SE
 DRUMS SE OF WAREHOUSE.

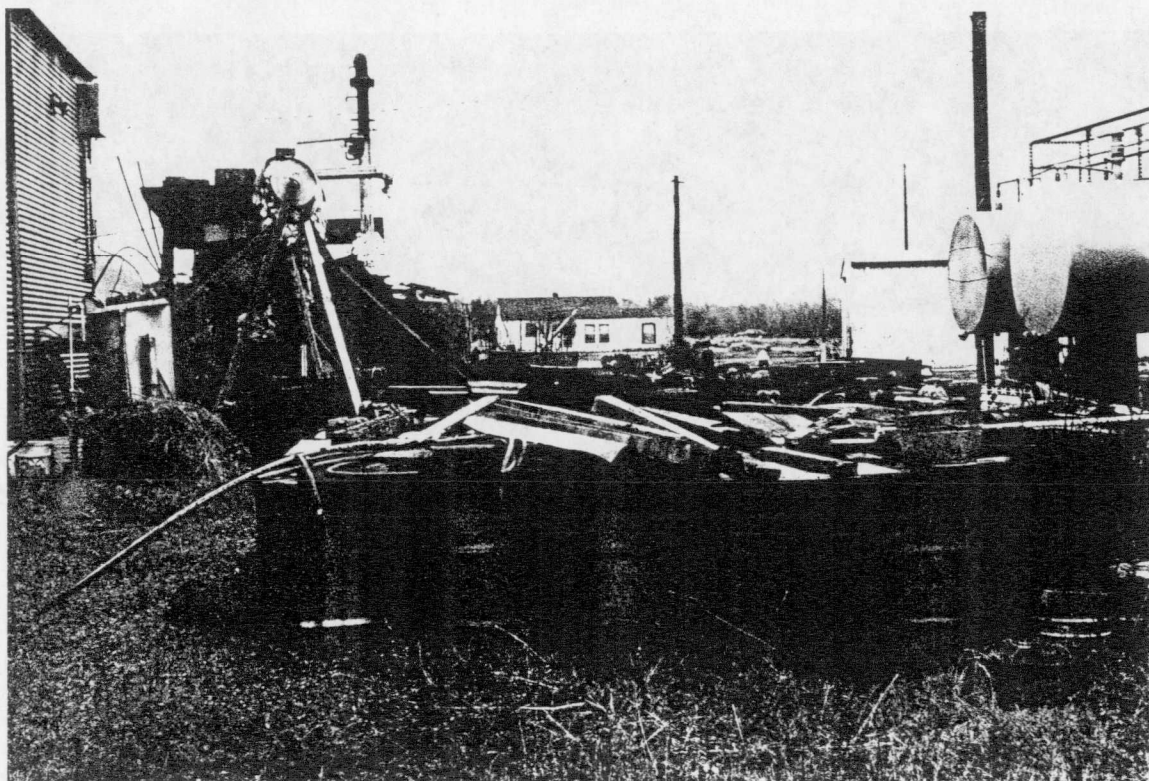
SITE NAME: EMCHEM CORPORATION TDD#: T06-9210-079
 PHOTO#: 215 PHOTOGRAPHER\WITNESS: REDDY/HAGLUND
 DATE: 01/12/93 TIME: 1021 DIRECTION: N
 DRUMS AND DEBRIS EAST OF WAREHOUSE.

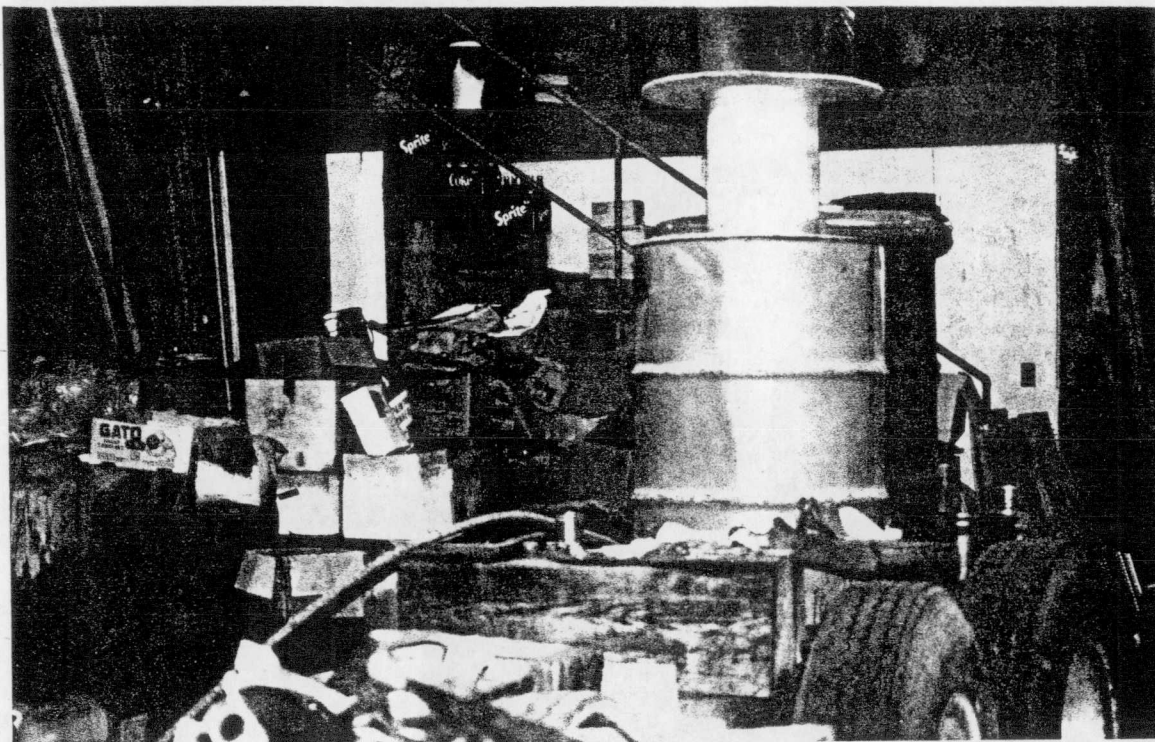
SITE NAME: EMCHEM CORPORATION TDD#: T06-9210-079
 PHOTO#: 404 PHOTOGRAPHER\WITNESS: BEESON\FEDDERS
 DATE: 02/09/93 TIME: 1552 DIRECTION: N
 VIEW OF FIVE-GALLON BUCKETS FILLED WITH GLYCOL MATERIAL

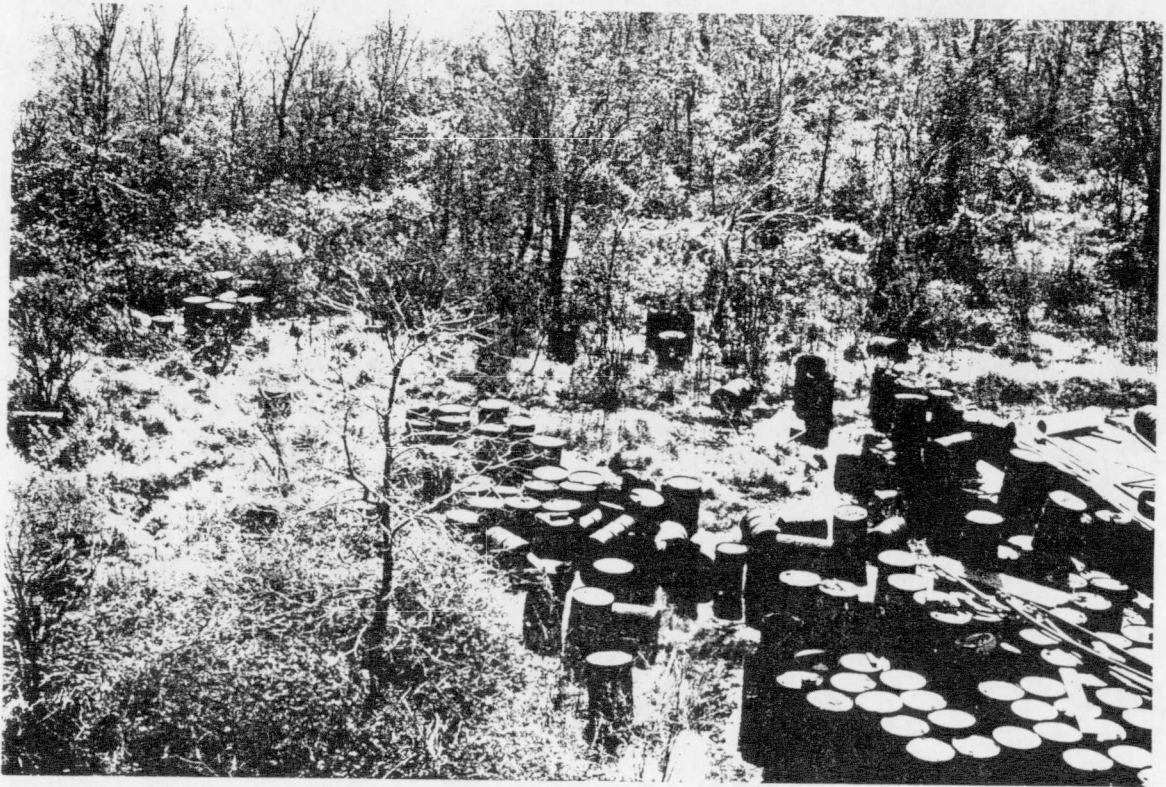
SITE NAME: EMCHEM CORPORATION TDD#: T06-9210-079
 PHOTO#: 315 PHOTOGRAPHER\WITNESS: BEESON
 DATE: 01/12/93 TIME: 1302 DIRECTION: SE-SW
 PAN OF SOUTH SIDE OF SITE.

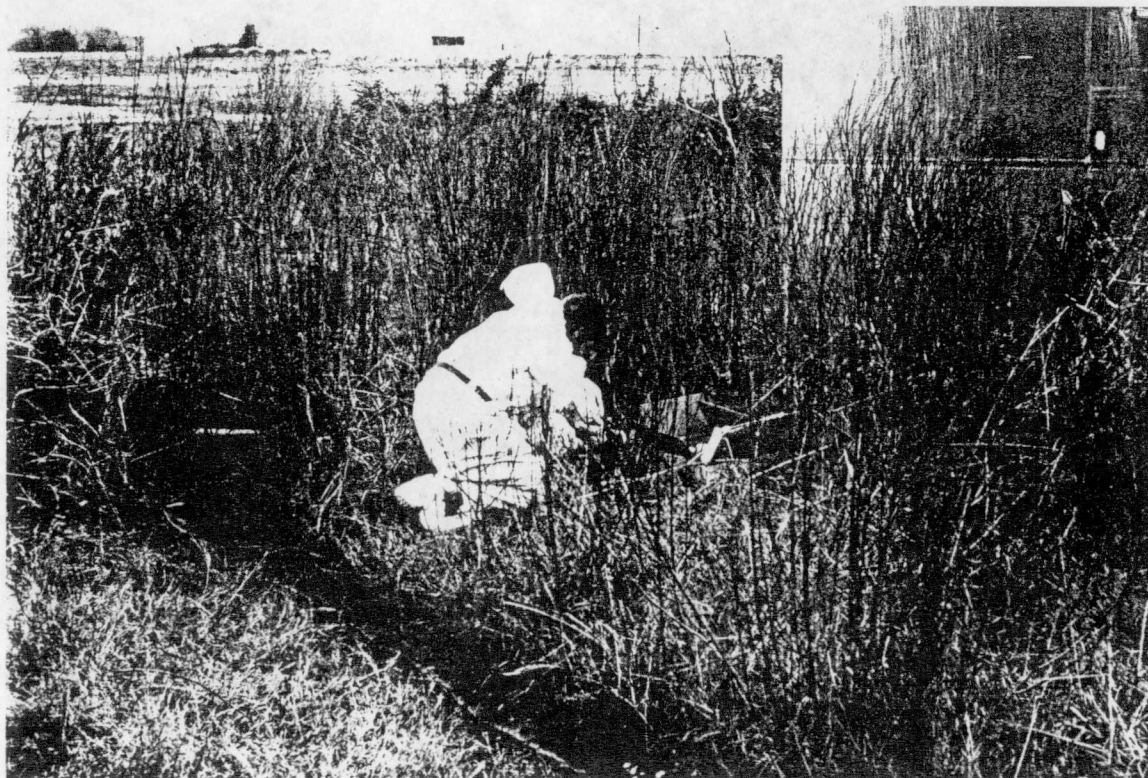
SITE NAME: EMCHEM CORPORATION TDD#: T06-9210-079
 PHOTO#: 308 PHOTOGRAPHER\WITNESS: REDDY/HAGLUND
 DATE: 01/12/93 TIME: 1242 DIRECTION: NE
 VIEW OF TAT TAKING SOIL SAMPLE S2.

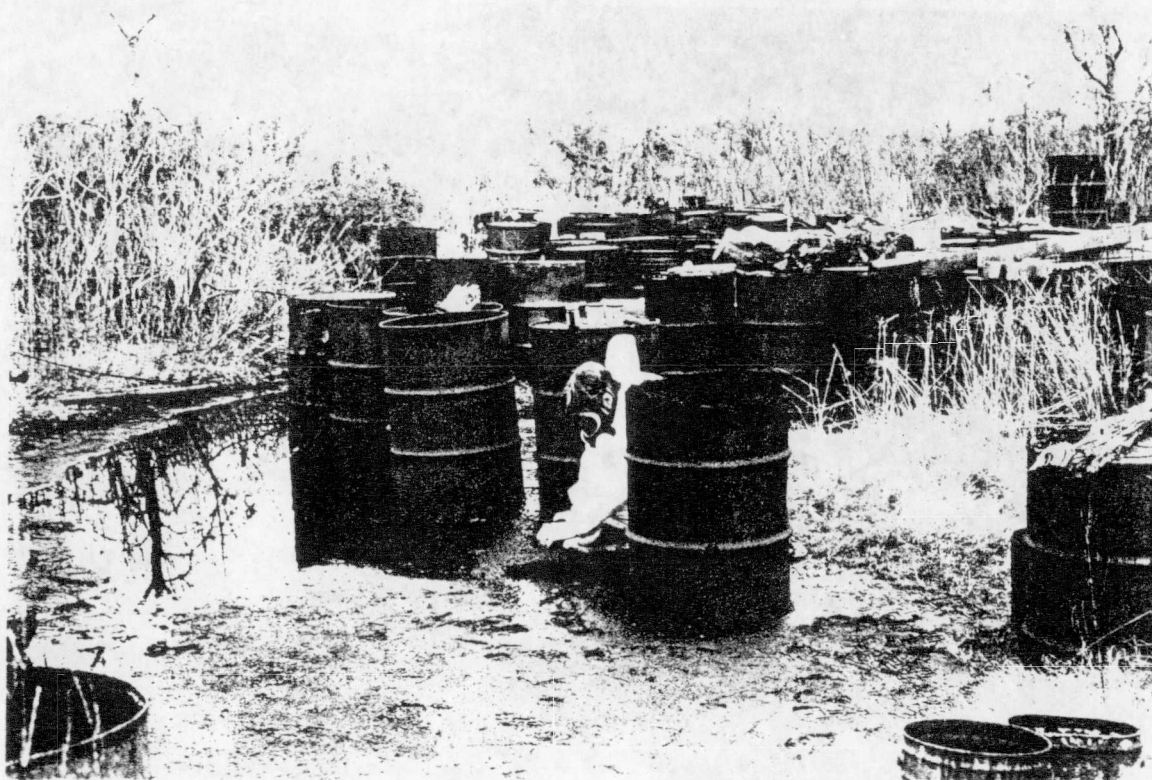
SITE NAME: EMCHEM CORPORATION TDD#: T06-9210-079
 PHOTO#: 309 PHOTOGRAPHER\WITNESS: REDDY/HAGLUND
 DATE: 01/12/93 TIME: 1245 DIRECTION: S
 VIEW OF TAT TAKING SOIL SAMPLE S3.

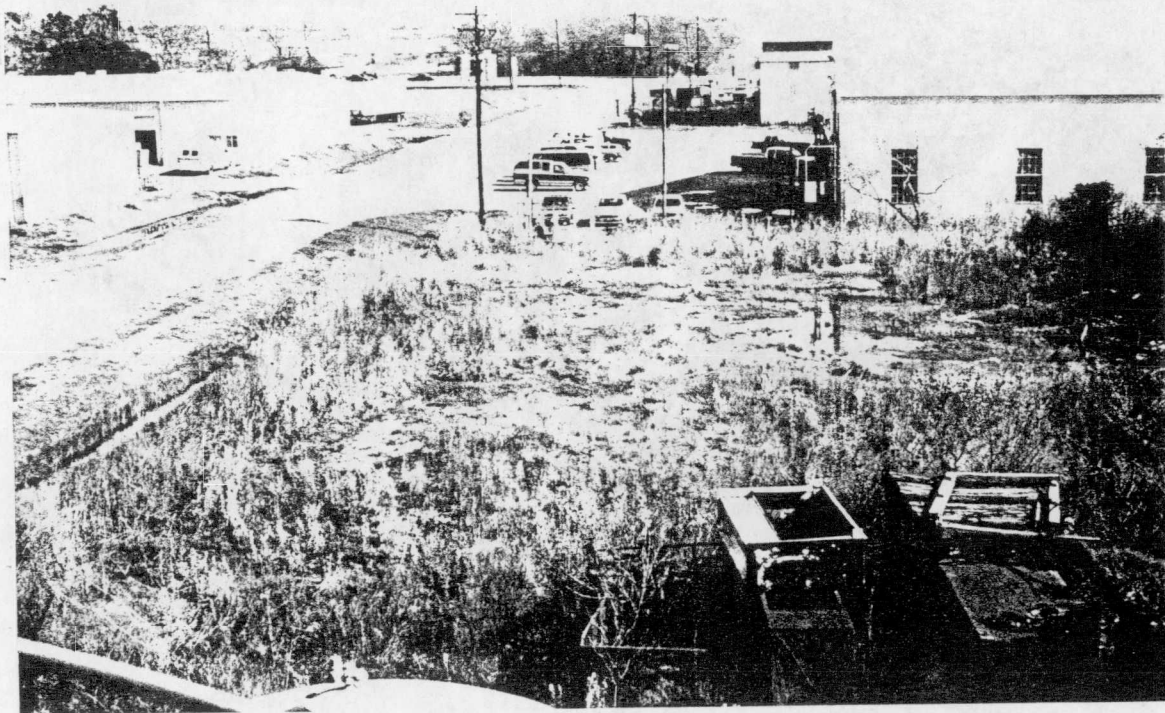
SITE NAME: EMCHEM CORPORATION TDD#: T06-9210-079
 PHOTO#: 313 PHOTOGRAPHER/WITNESS: BEESON
 DATE: 01/12/93 TIME: 1301 DIRECTION: E
 VIEW OF DRAINAGE OFF-SITE.

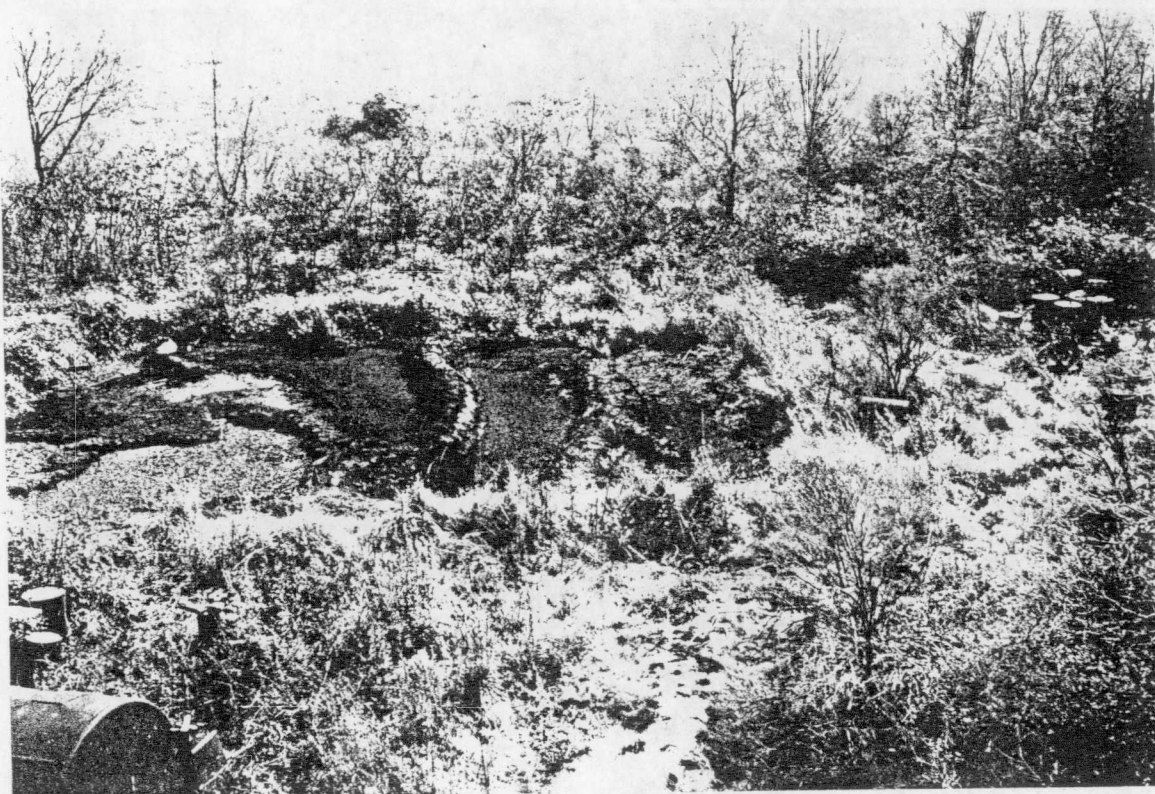
SITE NAME: EMCHEM CORPORATION TDD#: T06-9210-079
 PHOTO#: 314 PHOTOGRAPHER/WITNESS: BEESON
 DATE: 01/12/93 TIME: 1302 DIRECTION: SE-SW
 PAN OF SOUTH SIDE OF SITE.

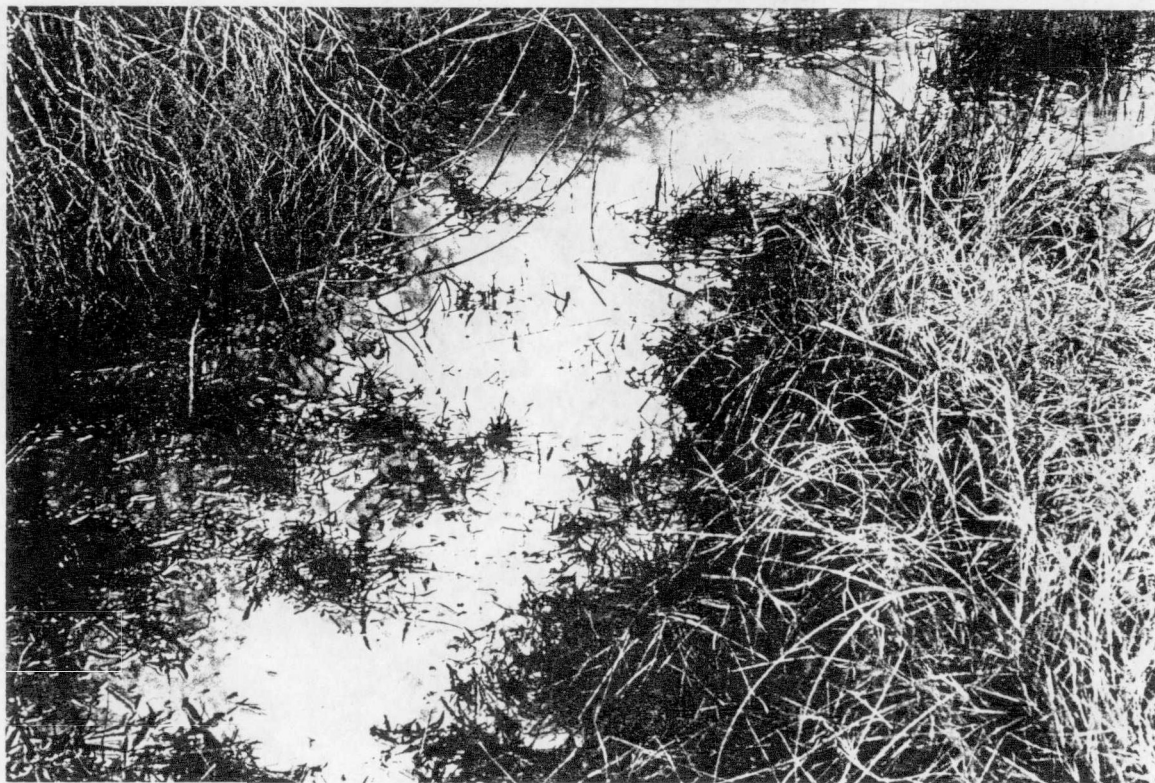
SITE NAME: EMCHEM CORPORATION TDD#: T06-9210-079
 PHOTO#: 222 PHOTOGRAPHER\WITNESS: REDDY/HAGLUND
 DATE: 01/12/93 TIME: 1030 DIRECTION: NW
 STANDING POOL OF WATER WITH SHEEN, SOUTH OF TANKS.

1040 Some drums have labels, but all appear rusted & open at top. A pool of oily liquid is towards the South of the Drum Area. Soil to the north of the facility and in the drainage ditch along road appears fairly clean.

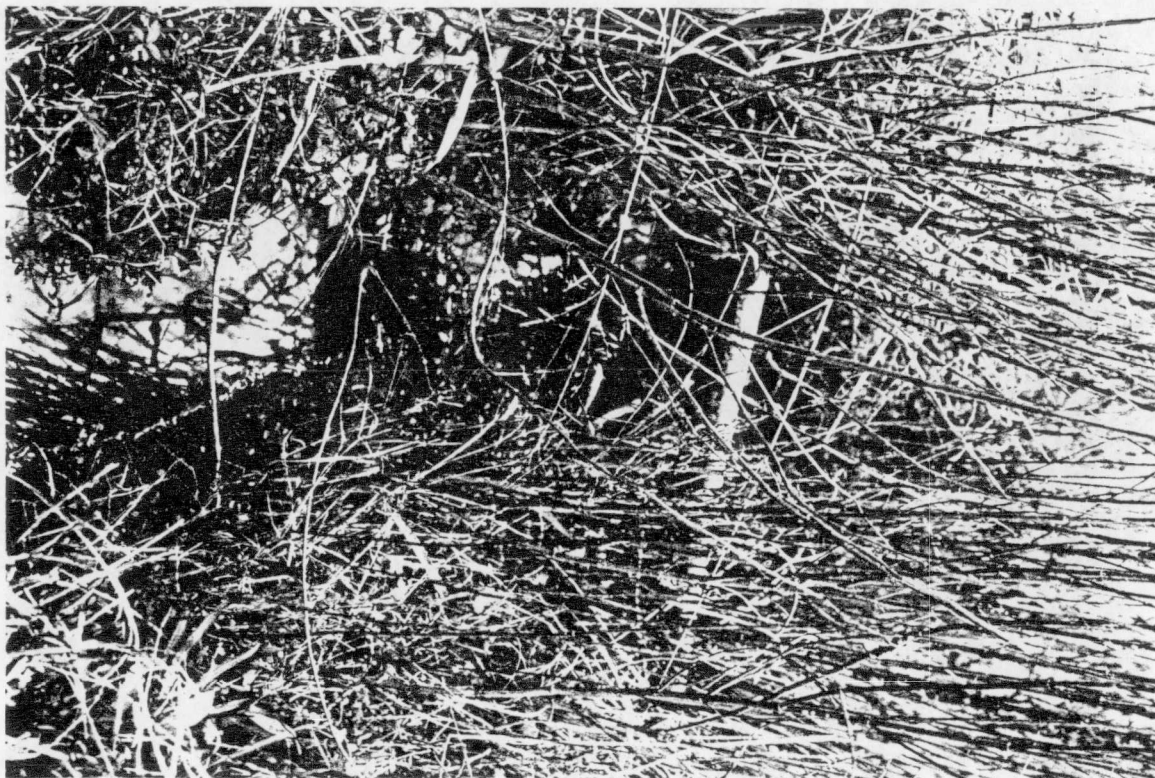
SITE NAME: EMCHEM CORPORATION TDD#: T06-9210-079
 PHOTO#: 302 PHOTOGRAPHER\WITNESS: REDDY/HAGLUND
 DATE: 01/12/93 TIME: 1100 DIRECTION: N
 SHEEN ON DRAINAGE TRENCH EAST OF TANKS T18 AND EBT.

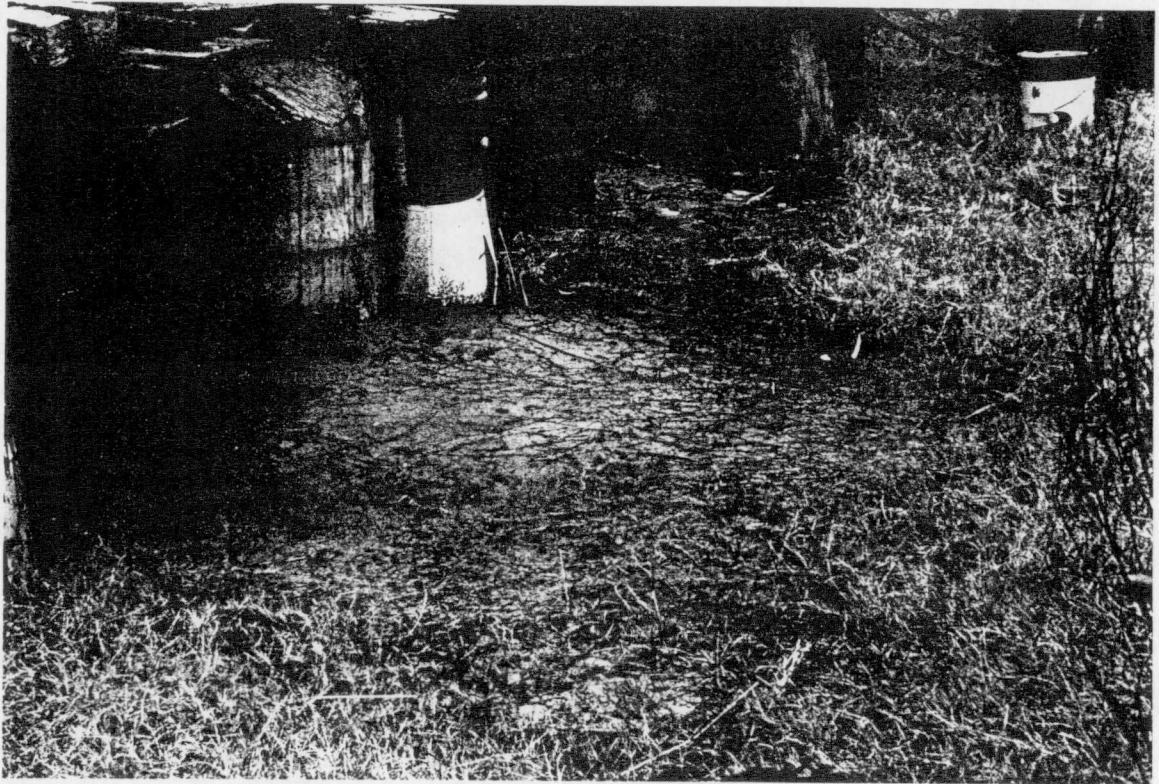
SITE NAME: EMCHEM CORPORATION TDD#: T06-9210-079
 PHOTO#: 217 PHOTOGRAPHER\WITNESS: REDDY/HAGLUND
 DATE: 01/12/93 TIME: 1024 DIRECTION: N
 DEAD VEGETATION AND STAINED SOIL NEAR DRUMS,
 EAST OF WAREHOUSE.

Soil in drum area is very stained - dark brown. Rusty drums are located throughout cleared area & a few are in the wooded area to the south. These appear to be rusty and empty.

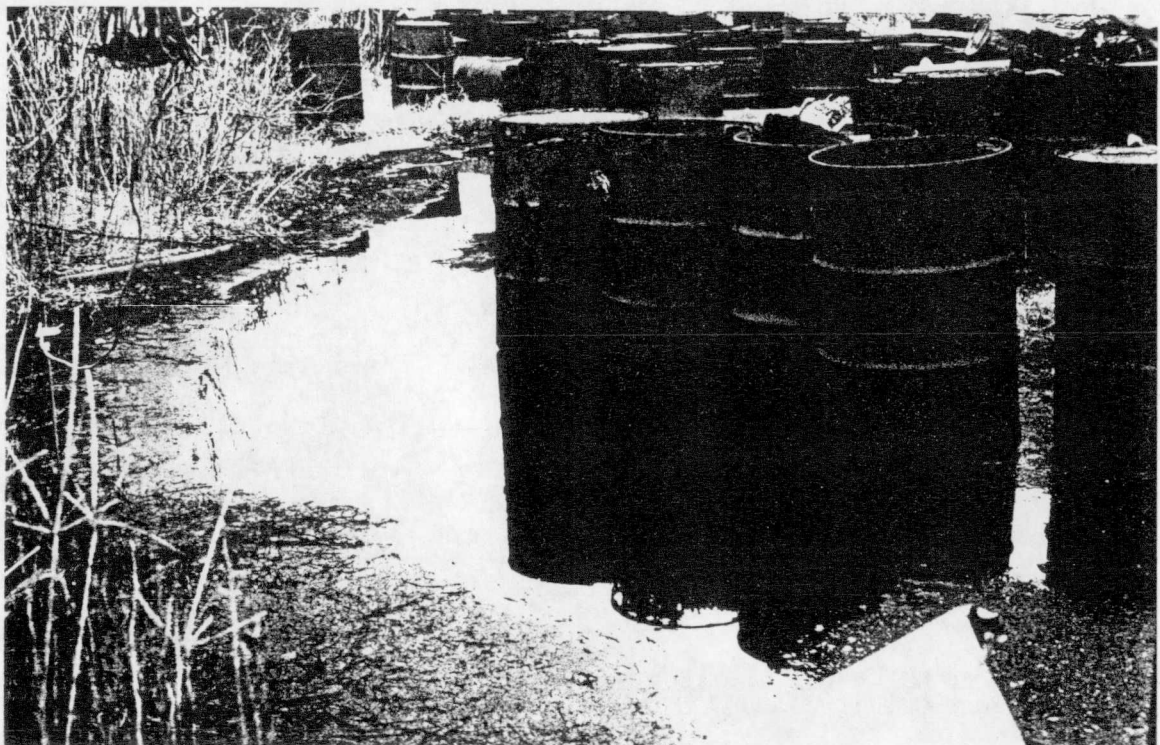
SITE NAME: EMCHEM CORPORATION TDD#: T06-9210-079
 PHOTO#: 218 PHOTOGRAPHER\WITNESS: REDDY/HAGLUND
 DATE: 01/12/93 TIME: 1025 DIRECTION: S
 DEAD VEGETATION AND STAINED SOIL NEAR DRUMS,
 SE OF WAREHOUSE.

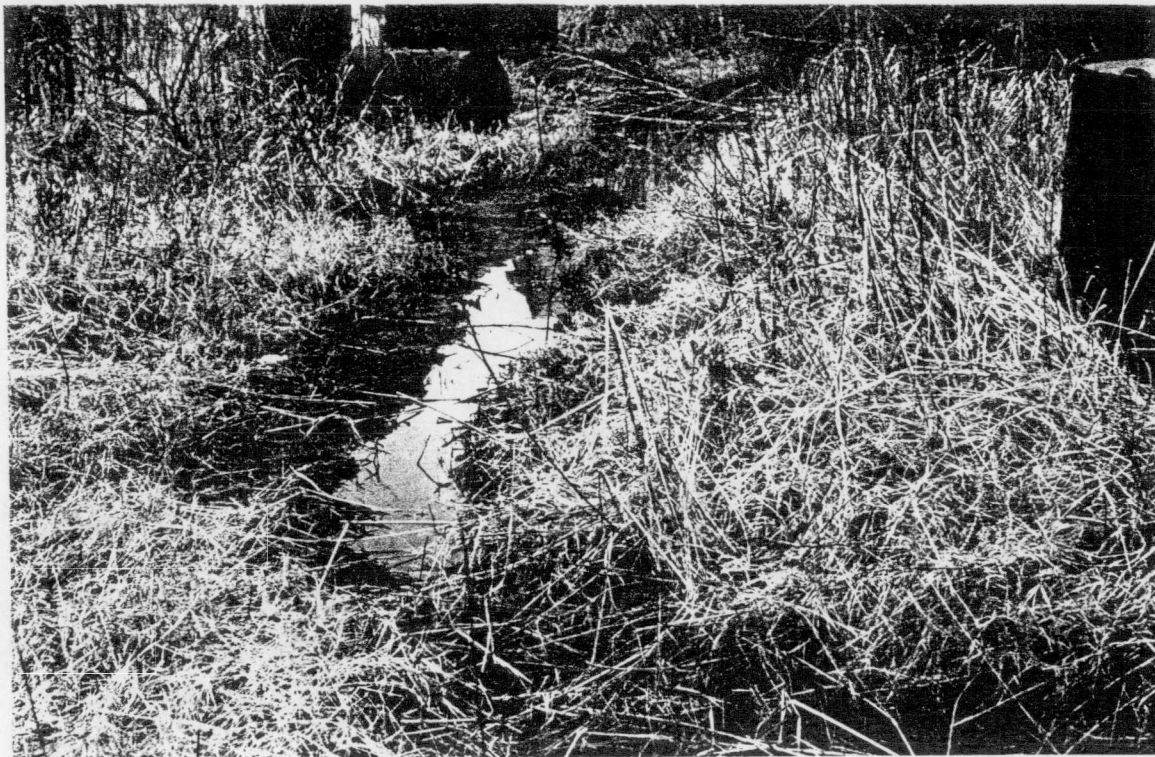
SITE NAME: EMCHEM CORPORATION TDD#: T06-9210-079
 PHOTO#: 220 PHOTOGRAPHER\WITNESS: REDDY/HAGLUND
 DATE: 01/12/93 TIME: 1028 DIRECTION: E
 WATER DRAINAGE THROUGH DRUM AREA SOUTH OF WAREHOUSE.

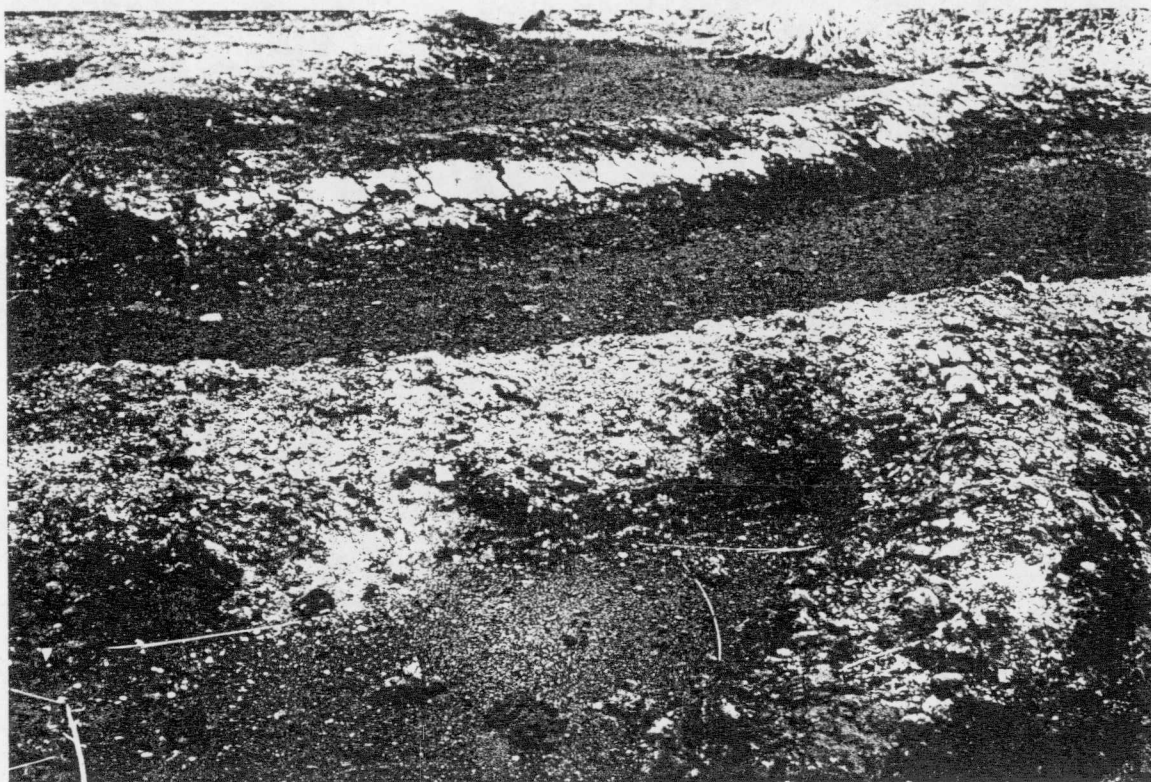
SITE NAME: EMCHEM CORPORATION TDD#: T06-9210-079
 PHOTO#: 221 PHOTOGRAPHER\WITNESS: REDDY/HAGLUND
 DATE: 01/12/93 TIME: 1029 DIRECTION: SE
 BERMED AREA SOUTH OF TANK BATTERY (LANDFILL).

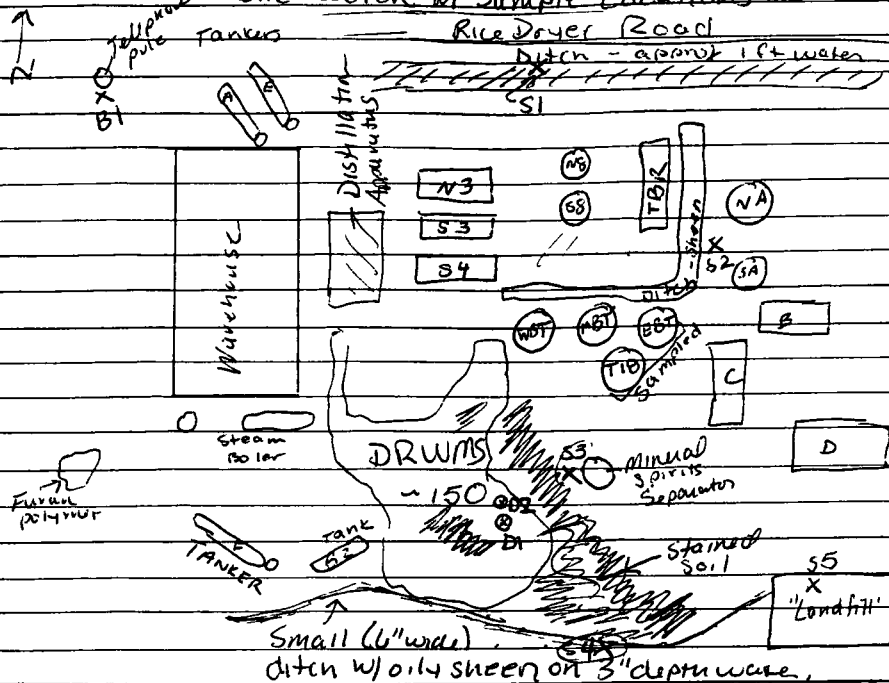
Site Sketch w/ Sample Locations

In addition, tank N3 is empty except for small amount of furan-resin. D. Miller did not specify contents of tanks S3 and S4.

Tank 32 also contained his product (same as EBT and T18). All other tanks on property are empty. (Tanks B, C, D and Tankers E, F) (my numbering).
